Laser Assisted Rehabilitation of a Bone Fracture

CASE SUMMARY

Diagnostics and Exam Findings: Dorsal cortical stress fracture of left front cannon bone on July 1st.

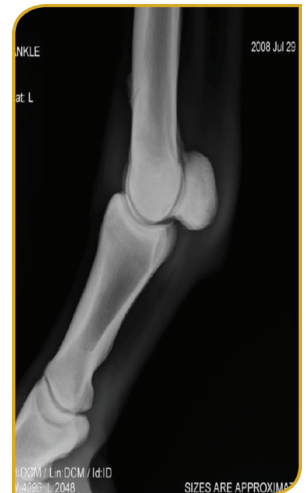
Four weeks post-presentation

Comments: The initial recheck radiograph (four weeks post-presentation) showed a significant improvement in the appearance of the fracture site. These injuries typically require three months to heal.
